Study of the Clogging Phenomenon of Submerged Nozzles in Continuous Casting

The continuous casting nozzle, which guides and protects the flow of liquid steel, undergoes a progressive reduction in its internal diameter following the accumulation on the internal wall of non-metallic inclusions. This narrowing of the channel is due to a mechanical attachment (non-metallic inclusions) which results from the turbulent regime of the flow of the liquid steel. This phenomenon is very often associated with the casting of low carbon steels deoxidized exclusively with aluminum. Clogging generally leads to a slowing down of the casting speed and, in severe cases, to the total stoppage of the installation and consequently to the appearance in the slab of the defect called resumption of casting or belt. The aim of this work is to determine the nature of the deposit and the blocking mechanism of the pouring nozzles. For that, a chemical analysis as well as tests concerning the adhesion of the deposit were carried out on samples taken from damaged pouring nozzles. We found that it was at a load of 187.5 kgf that the rupture of the sample took place, during the interfacial indentation tests, which

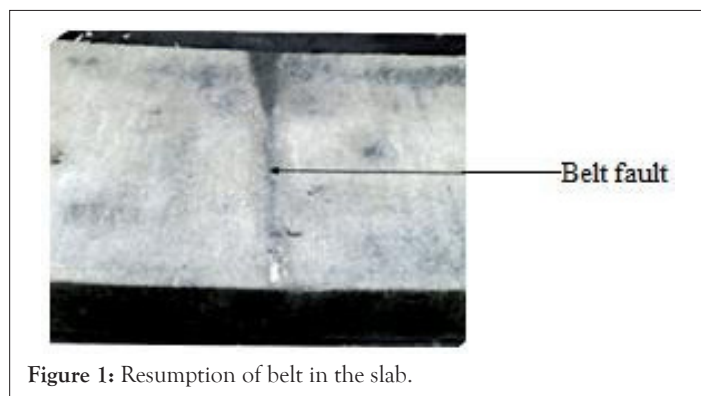
The blockages of the nozzles affect the quality of the slabs in the form of "belts" which can be defined as a discontinuity in cross section of the slab; Figure 1 shows a resumption of casting or belt in the slab.

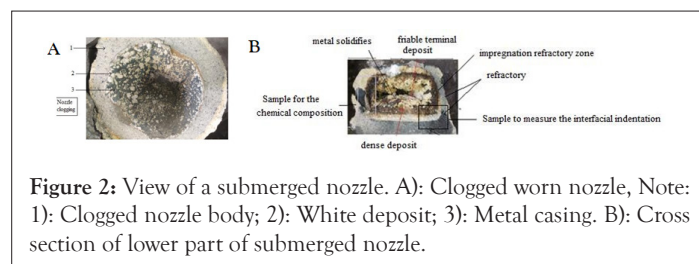
Figure 2: View of a submerged nozzle. A): Clogged worn nozzle, Note: 1): Clogged nozzle body; 2): White deposit; 3): Metal casing. B): Cross section of lower part of submerged nozzle.

The localization of the deposit having blocked the nozzle was carried out by observation with the naked eye. The morphological identification of the deposit consists of observing a sample using a binocular magnifying glass. The sample was cut from the lower part and cut by an ordinary chainsaw, and then we detached the metal envelope, as well as the terminal deposit and leaving only the dense deposit, which adheres to the refractory body of the nozzle. Figure 2 shows clogged worn nozzle and cross section of a submerged nozzle.

The lower part is almost completely clogged by a deposit, while the deposit in the upper part only measures a few millimeters;

The deposit formed on the inner wall of the lower part can be divided into three layers:

- A gray metallic envelope.
- Layer of slag having a thickness comparable to that of the deposit formed on the upper part.
- An extremely thick deposit, several centimeters long with a crumbly appearance, in the form of a powder stuck to another white deposit, denser and less thick.

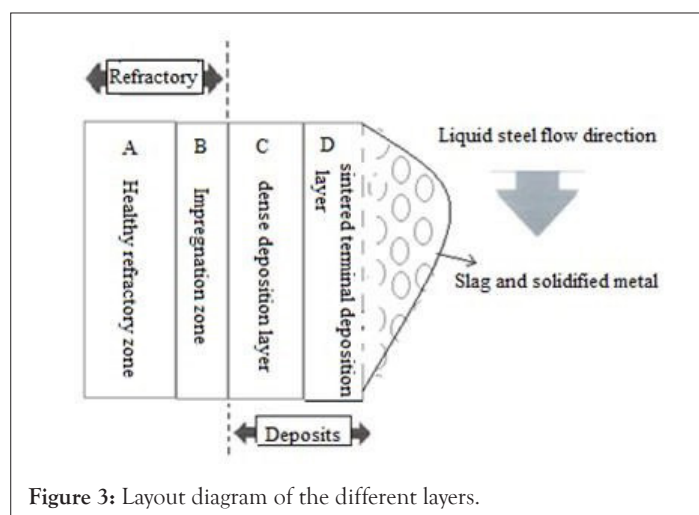
Figure 3: Layout diagram of the different layers.

The metal casing and the deposit of the lower part of the nozzle are made up of a mixture of slag from the converter and metal oxides resulting from deoxidation, Figure 3 indicates layout diagram of the different layers.

The taking of the samples of the deposit to carry out the chemical composition is carried out by a chainsaw, then to take off the dense deposit (C), from the impregnated refractory zone (B), we used a hammer and a chisel, then in the same way we separated the affected refractory zone (B) from the healthy refractory (A). Figure 4 explains materials obtained after separation.

After the macro morphological identification of the deposit, we took a sample from each zone as shown in the Figure 3.

In the Figure 3, we have divided our nozzle profile into two parts according to the nature of the base materials (refractory or steel), the results obtained after chemical analyses by X-ray fluorescence are collated in Table 2, namely:

Refractory: It comprises the zone of sound refractory (A), as well as the zone of the layer of refractory affected by impregnation (B).

Deposit: It comprises the dense deposit (C) as well as the terminal sintered deposit (D).

To prepare our samples, we recovered a used nozzle, which we cut in the transverse direction as shown in Figure 3.

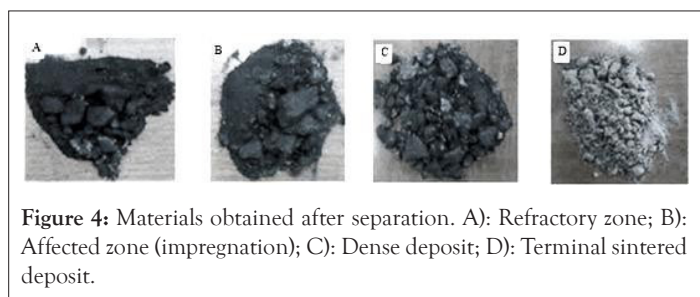
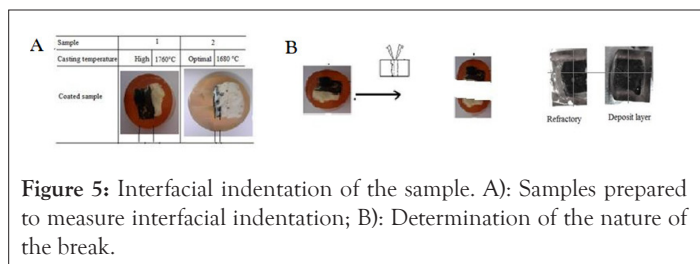
Subsequently, we cut these samples with the Mecatome TZ 10 type micro-cutting machine, until a flat and uniform sample was obtained and, because of its low thickness ($3\text{-}5\ \text{mm}$), this sample was coated with epoxy as shown in Figure 5A, samples were prepared to measure interfacial indentation.

To perform the interfacial indentation, we used a Vickers microhardness tester, a Vickers hardness tester, and finally a Rockwell hardness tester until the part was destroyed. Figure 5B explains determination of the nature of the break.

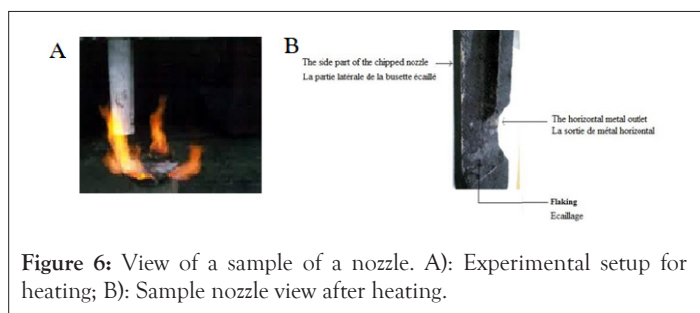
Figure 6: View of a sample of a nozzle. A) Experimental setup for heating; B) Sample nozzle view after heating.

Laboratory experimental setup: We have studied the influence of preheating new nozzles at a fairly low temperature (750°C), for variable heating times in an uncontrolled atmosphere. We carried out an experimental assembly, which consists of a bracket to hold the nozzle, a natural gas burner and an ordinary pyrometer for temperature control. Figure 6A shows nozzle experimental setup.

Nozzle heating sequence at the factory: The heating time from the nozzle to the surface is 8 h and more in some cases, the burner is oriented towards the bottom of the nozzle which undergoes intense heating over 1000°C while the top remains relatively cold, knowing that refractories are poor conductors of heat, this temperature difference causes the surface to burst, the consequence of which is spalling. Figure 6B shows sample nozzle view after heating.

To minimize the phenomenon of clogging of the nozzles, it is proposed to preheat the nozzles immersed in a furnace, which ensures homogeneous preheating under a controlled atmosphere for an optimal lifespan.

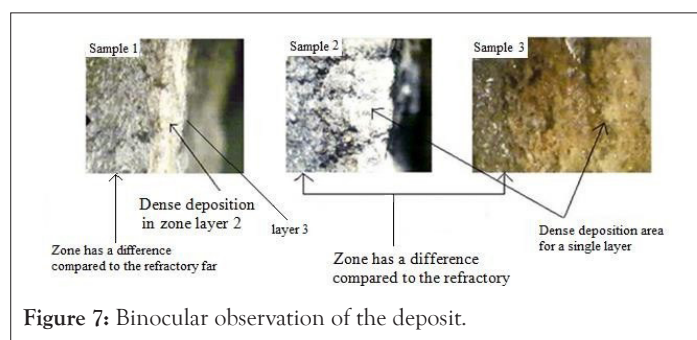
The observation of the deposit was carried out using an Optika digital binocular loupe, the photos of the different samples with an enlargement of 200 μm , Figure 7 shows binocular observation of the deposit.

The results obtained are contained in Table 1. From these results, we can say that in addition to the layer separated before the observation and the dense deposit adhered to our samples, we detected a third layer of refractory origin according to its macroscopic morphology and its color. After these observations, the new configuration of the deposit layers then becomes included inside the healthy zone according to the following order:

First zone: It is the decarburized zone called the impregnation zone; its thickness is between 300-3000 μm .

Second zone: It is the dense deposit zone, white color with dark brown spots and light brown spots. Its thickness is between 200-6250 μm .

Third zone friable terminal deposit: It is a very thick and very friable layer.

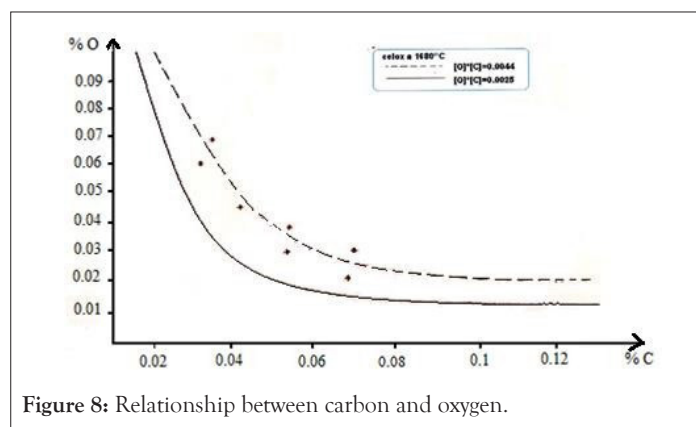
Figure 8: Relationship between carbon and oxygen.

At the end of the refining operation and just before casting, it is useful to measure the oxygen activity in order to be able to determine the quantity of deoxidizer to add to the bath at a temperature of 1680°C. The results of the measurements of the activity of oxygen in our case enabled us to construct Figure 8 where we note that the equilibrium concentration of oxygen at the end of blowing is clearly higher than that of the theoretical equilibrium curve.

All the conditions favorable to the increase of oxygen dissolved in the liquid metal are therefore united. To deoxidize steel, a large amount of aluminum is used. The activity of the oxygen in the liquid steel must be reduced as much as possible to avoid the formation of blisters, but too much quenching with aluminum causes the clogging of the nozzles by the inclusions of alumina.

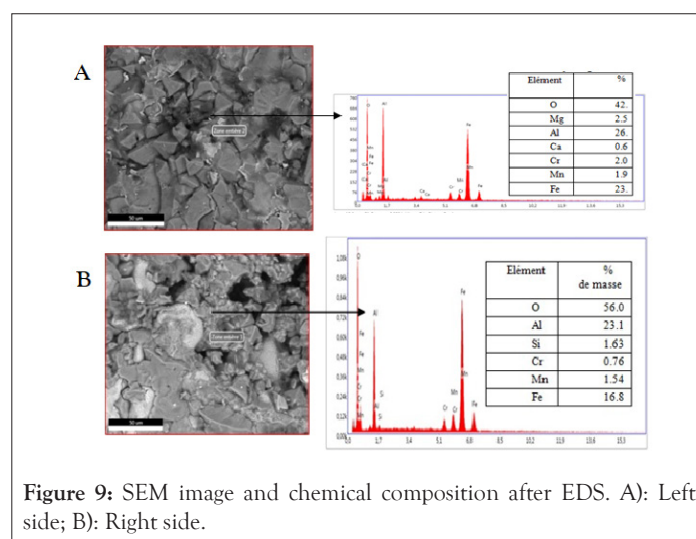
Figure 9: SEM image and chemical composition after EDS. A): Left side; B): Right side.

We operated in the same way as the previous tests except that this time we started with a load of 60 kgf, but only at 187.5 kg. Force that the damage has taken place as shown in Figure 8. We consider that this load represents the level of adhesion of the deposit on the internal wall of the refractory, which is quite high. The observation by the Scanning Electron Microscopy (SEM) of the two faces after the interfacial indentation and the chemical analysis by EDS of the two points selected by the crosses in wire showed that there was a brittle rupture and not a detachment, indeed, one observed in Figures 9A and 9B, the same chemical composition, (the iron and aluminum (percentage (%)) peaks are superimposable).

The study of the images of the SEM and EDS of the two faces of the damaged sample shows a similarity from the point of view of chemical composition and structure so we can affirm that the sample rather suffered a brittle fracture at the maximum load of 187.5 kg and not a detachment for the separation, of the dense

layer and the refractory wall of the body of the nozzle thus showing a fairly high level of adhesion, which is explained by:

The impregnation zone of the internal walls of the nozzle leaves cavities where steel droplets, containing non-metallic inclusions, freeze, and cause the growth of the initial deposit by accretion phenomenon, we know that these are particles of non-metallic inclusions, remained in suspension which while crossing the nozzle cling to the wall of the tube and cause in time, the reduction of the passage of the metal until the complete reduction of the internal diameter of the nozzle. After nozzle internal fattening, indicates the level of growth of refractory nozzle flow channel clogging, the components of the clogging which react easily with the walls of the nozzle during the passage of the molten steel are oxides.

Balances (MEB) and EDS of both sides of the sample showed us that the fracture is of a brittle nature since we have the same chemical composition on both sides of the sample.

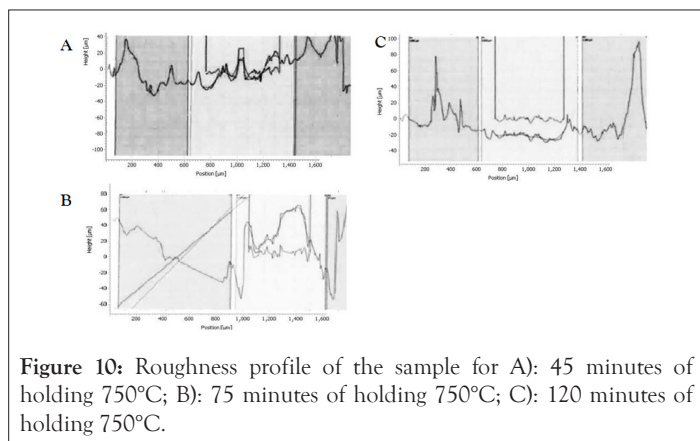
Figure 10: Roughness profile of the sample for A): 45 minutes of holding 750°C; B): 75 minutes of holding 750°C; C): 120 minutes of holding 750°C.

The roughness test gives us the graphs of Figure 10.

The results of the graphs (Figure 10) enabled us to construct the histogram of Figure 11. Indeed, the study of this histogram shows that the roughness decreases with the increase of the time of maintenance of the temperature. The roughness, after 120 min of maintenance at a temperature of 750° C., increased from 8.3 μm before heating to 2.81 μm , we can explain this decrease by the crumbling of the spikes during the roughness tests. In the industrial case, the preheating of the nozzles is rather anarchic and unbalanced, which has caused spalling at the level of the internal wall of the nozzle.

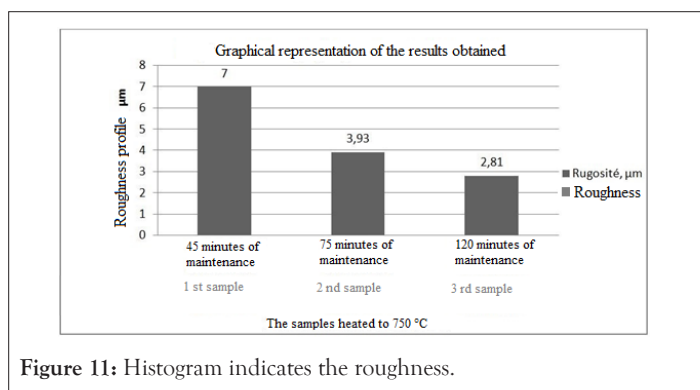
Figure 11: Histogram indicates the roughness.

The histogram in Figure 11 shows the roughness of the sample.

Among the factors that increase the adhesion of non-metallic inclusions (Al_2O_3) on the internal walls of the casting nozzle is the presence of flaking which is due to the overheating of the lower part of the nozzles (more than 1000°C) for a fairly long time (more than 8 h) in the conditions of steelworks. Indeed, the experiment carried out in our laboratory on three samples heated to 750°C with different holding times has shown that the internal surface condition of the nozzles is smoother, and that there is rather has an improvement in the state of the interior surface as evidenced by the roughness tests indeed.
