Assessment of the Impacts of Ground Fissuring in the Main Ethiopian Rift: The Case of the Rift Margin Areas of Siltie Zone, Southern Ethiopia, East Africa

ABSTRACT

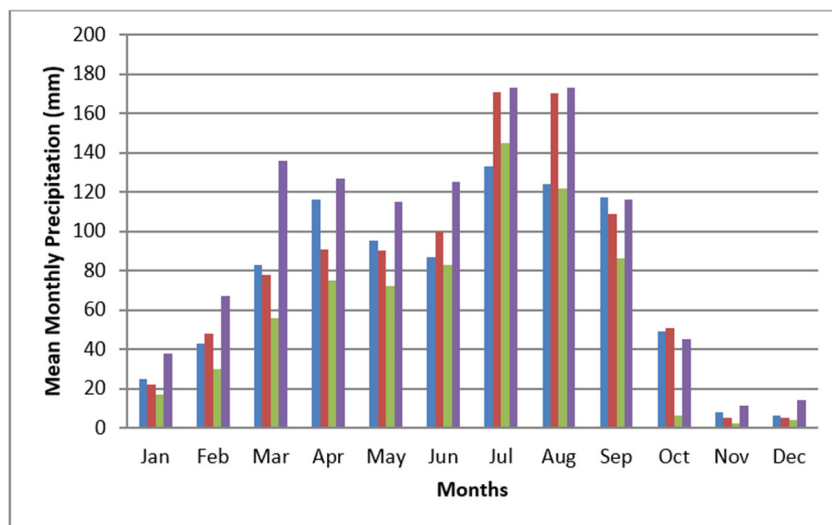
Figure 4: Precipitation pattern of the study area. Note: (■): Tora; (■): Koshe; (■): Ziway; (■): Butajra.

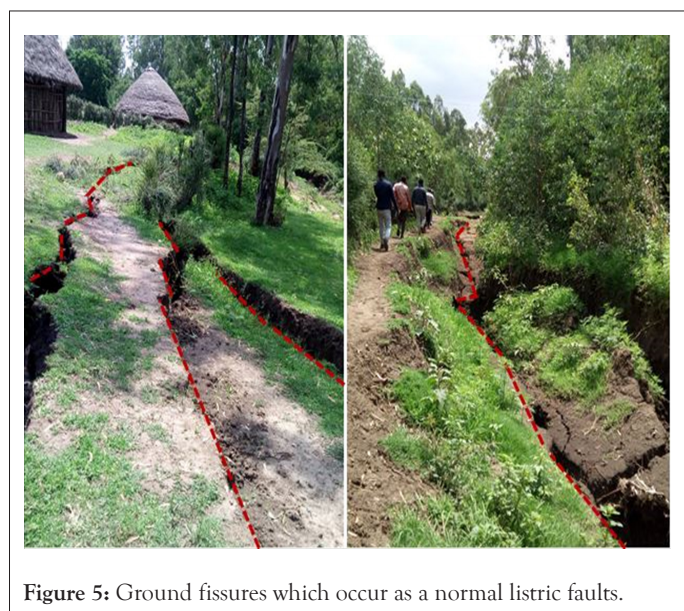
Majority of the ground fissures in the area occur as vertical cracks. However, in some sites fissures which follow a normal listric fault fashion are also encountered as shown in Figure 5. The sizes of the ground fissures range from discontinuous hairline fractures to open ground cracks up to 600 m long, as much as 0.5 m to 6 m wide, and up to 4.2 m deep as shown in Table 2. However, the actual depth is greatly reduced due to the collapse of ceilings and walls of the cracks and difficult to exactly determine from field observations and measurements. Many of the fissures observed show vertical offsets. Field observations indicated that all the fissures are aligned NNE-SSW directions, the average strike being N16°E.

Figure 5: Ground fissures which occur as a normal listric faults.

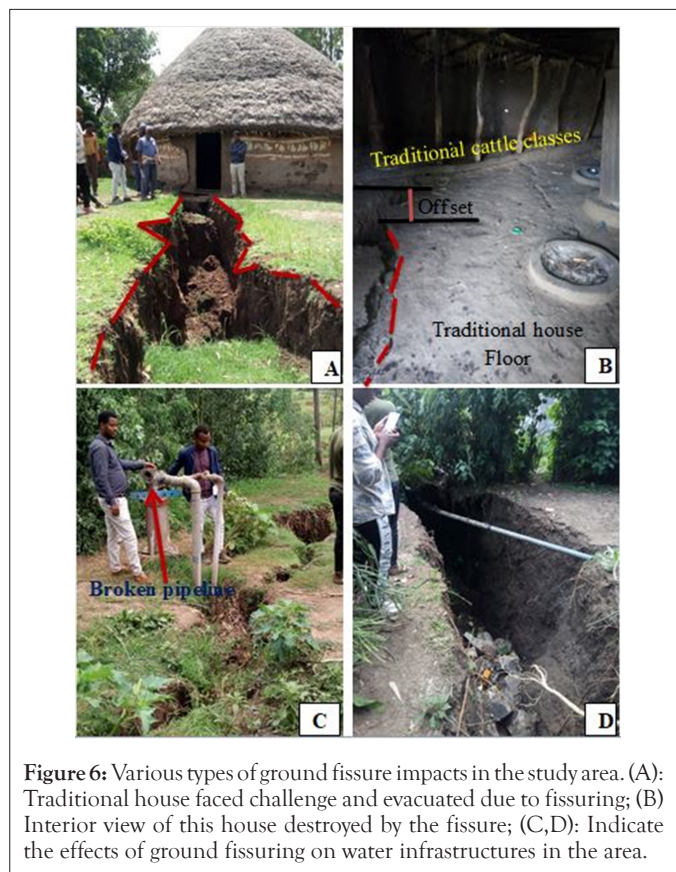
During the field survey, it is observed that the ground fissures had created many damages. The foremost problem that the ground fissure has caused in the study area is destruction on manmade structures such as homes, water pipelines and storage tankers. Figure 6a shows the local peoples traditional house which is damaged by fissuring and whose inhabitants are evacuated due to the May 2019 ground fissuring in the area. Figure 6b further illustrates the destructions caused at the interior of this house and the vertical offsets on the floor of the house. The ground fissures also brought severe damages on groundwater wells, water storage tankers, and water transmission pipelines as shown in Figures 6c and 6d. Interviews made with the local residents indicate many people do not get drinking water in their locality due to destruction of water lines by the fissures and as a result people are traveling long distances to get potable water.

Figure 6: Various types of ground fissure impacts in the study area. (A): Traditional house faced challenge and evacuated due to fissuring; (B) Interior view of this house destroyed by the fissure; (C,D): Indicate the effects of ground fissuring on water infrastructures in the area.
